# Automotive Crash Data Collection and Analysis: A Log-Based Case Study

**MobiSec 2024**

Author : Jeehun Jung, Kyoungwon Suh, Seong-Je Cho, Gyunseung Ahn

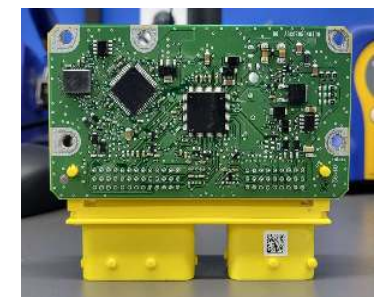
ACM(Airbag Control Module)

- Vehicle accident data analysis has predominantly focused on event data recorders (EDRs)
- **Capturing crucial information** about the vehicle during a brief period before and after a collision
- Limitations of Accessing EDR Data
  - It varies across automobile manufacturers
  - Analysis is often restricted by its proprietary formats

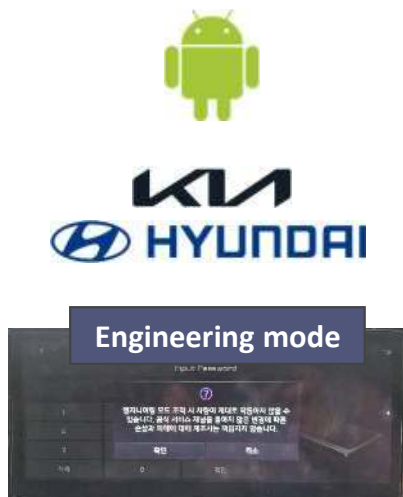
## Identification

- Android OS version
- Model of the IVI system
- How to enter Engineering mode

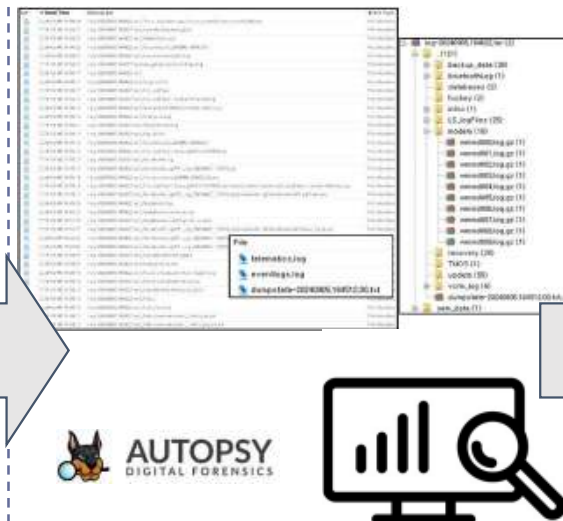
## Data analysis

- Extract meaningful evidence related to the incident

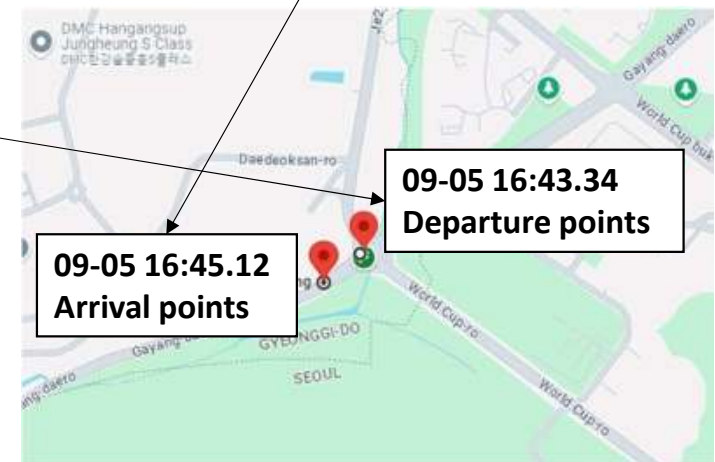
Vehicle Position

- ./telematics.log, ./dumpstate-[date].txt
- 'Address\_name' filed
- Latitude and Longitude are masked

Latitude: 37.580222\*\*  
Longitude: 127.876086\*
